BRAVO ZULU

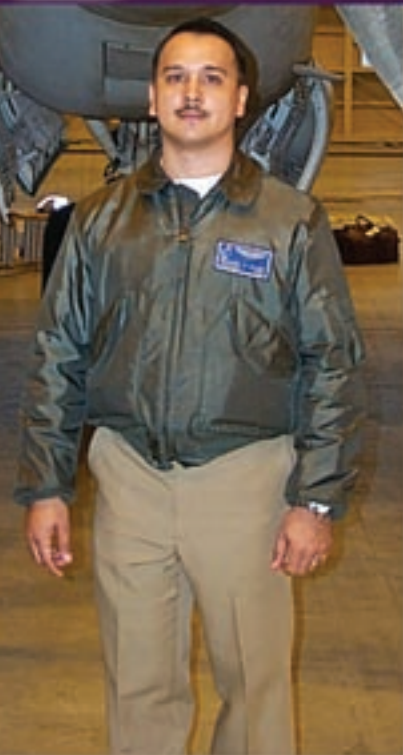
ADC Mike Allen

A P-3 aircrew had experienced a binding No. 3 power lever and simultaneous illumination of the negative-torque sensing light while power levers were being adjusted. The two troubleshooting steps were replacement of parts and adjustments of rigging.

Mechs adjusted the propeller valve housing and engine power-lever rigging three times, replaced three valve housings and two propeller control units, and changed the propeller-control, anti-rotation bracket and negative-torque sensing-bracket. The condition persisted. Nearly 1,000 man-hours were expended in the troubleshooting and repair efforts to solve this unusual discrepancy.

Chief Allen demonstrated superior technical expertise, troubleshooting techniques, and out-of-the-box thinking when he checked for wear on the side mounts for the reduction gear box. He found a loose inboard mount, through-bolt nut, and the outboard bolt had backed off completely.

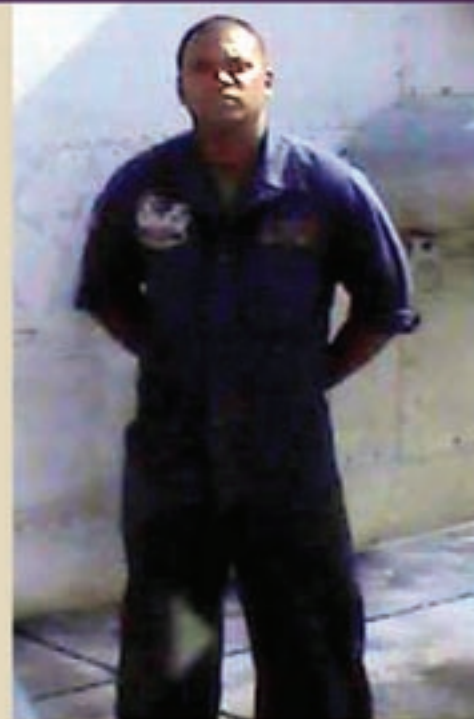
LCpl. Shaun Radhay

While in transit to Operation Iraqi Freedom aboard USS *Saipan*, LCpl. Radhay was doing a preflight inspection on an AH-1W. During this task, he found a large crack in one of the main-rotor blades.

LCpl. Radhay quickly notified QA, and the aircraft immediately was grounded. His discovery was reported in a hazrep and led to a fleetwide inspection of AH-1W main-rotor blades.

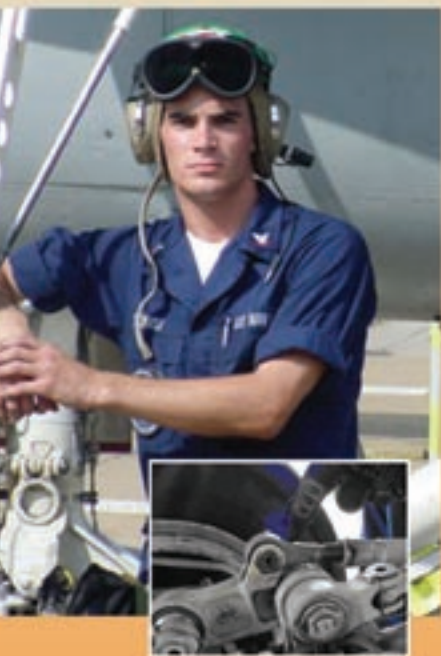
AT3 Daniel Iadonosi

Petty Officer Iadonosi was a line troubleshooter on the launch of aircraft 304. He was on the port side of the Hornet when he found a broken bolt head on the planing-link assembly for the main-landing gear. He discovered this problem during post-start, fluid-level and integrity checks.

Taking decisive action, AT3 Iadonosi aborted the launch and downed the aircraft. A closer look showed the bolt had failed because of subsurface corrosion and fatigue. With the bolt head missing, internal friction was the only force holding the shank remnants between the Heim-joint bearing and the planning-arm assembly. This bolt would have fallen out and could have caused a total planning-link failure.

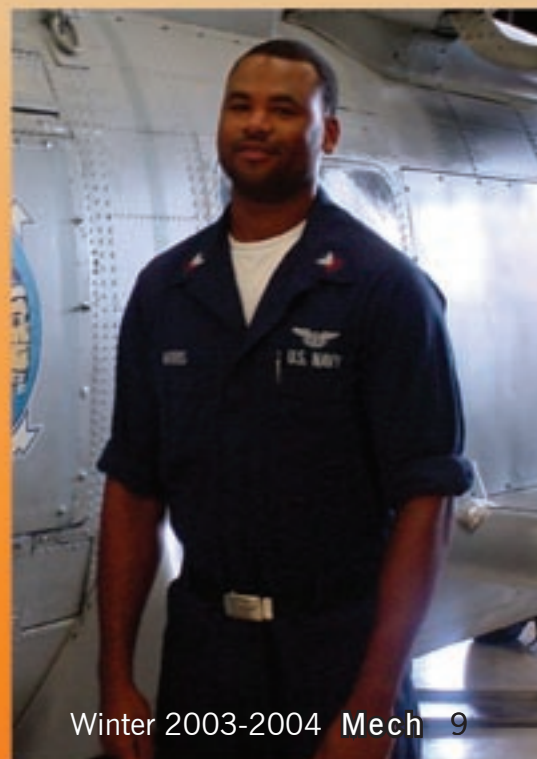
AD2 Edgar Morris

While waiting for his "Proud Warrior" aircraft to taxi, Petty Officer Morris noticed a sister squadron's aircraft move toward the runway. He watched and waited for that other helo to clear the line, so he could taxi his own aircraft. He suddenly saw the engine-cowling doors on the taxiing aircraft were not secured. Turning over his aircraft to the fireguard, who also was a qualified PC, Petty Officer Morris entered his aircraft's rotor arc to tell his crew to notify the other crew via the radio. That other helo was shut down, and the problem was fixed.
